Manhole Inspection Summary

Manhole # S63G__025MH

Location Address: **5100 Bayview Blvd.**

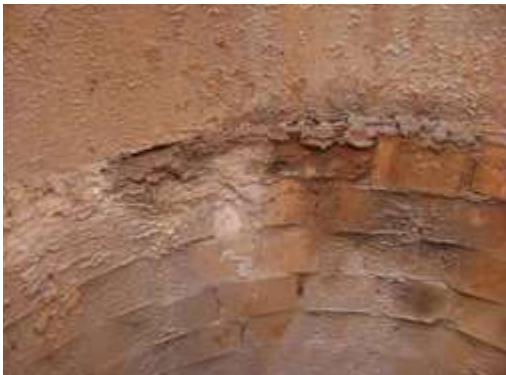
Defect 3

Infiltration: ☐ None ☒ **Joint** ☐ Cracks ☒ **Mortar** ☐ Roots ☐ Wall

infiltration at frame joint

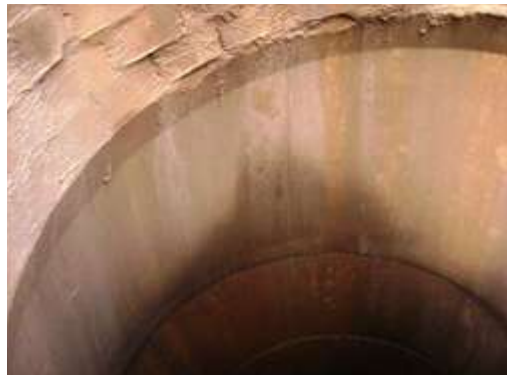
Defect 5

Infiltration: ☐ None ☒ **Joint** ☐ Cracks ☐ Mortar ☐ Roots ☐ Wall

infiltration in barrel

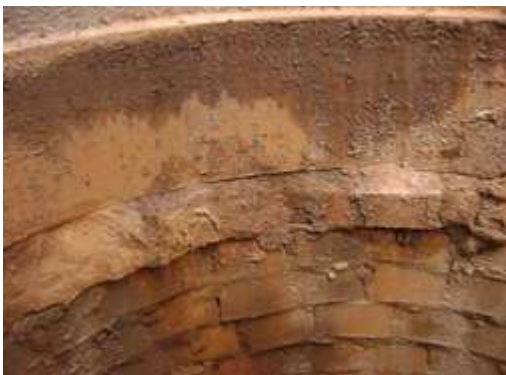
Defect 2

Condition: ☐ Sound ☐ Cracked ☐ Root Intrusion ☒ **Loose Brick** ☒ **Deteriorated**

loose bricks

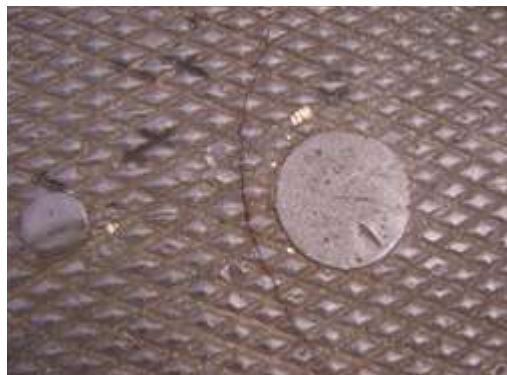
Defect 1

Condition: **Cracked**

crack in cover

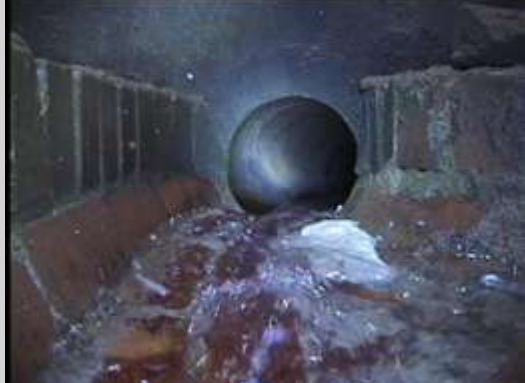
12 O'Clock Outflow

Pipe Height: **8.4** (in.) Rod and Bar (Angled)
Pipe Material: **Clay** ☐ Pipe Lined
Invert Depth: **16.67** (ft.) Flow Characteristics: **Fast**
Deposits: ☒ None ☐ Mud ☐ Sludge ☐ Debris ☐ Grease
Silt Depth: (in.) Deposits Extent:
Infiltration: **None** Pipe Seal Cond: **Sound**

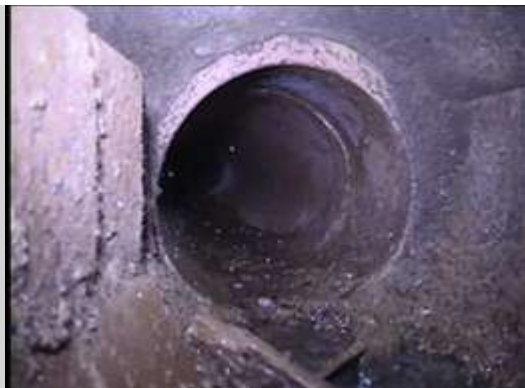
3 O'Clock Inflow

Pipe Height: **8.4** (in.) Rod and Bar (Angled)
Pipe Material: **Clay** ☐ Pipe Lined
Invert Depth: **16.58** (ft.) Flow Characteristics: **Slow**
Deposits: ☒ None ☐ Mud ☐ Sludge ☐ Debris ☐ Grease
Silt Depth: (in.) Deposits Extent:
Infiltration: **None** Pipe Seal Cond: **Sound**

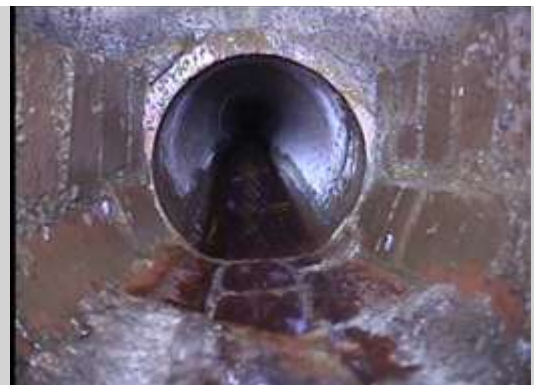
6 O'Clock Inflow

Infiltration: **None** Pipe Seal Cond: **Sound**
